Manhole Inspection Summary

Manhole # S53I__023MH

Location Address: **behind 429 S.Robinson St.**

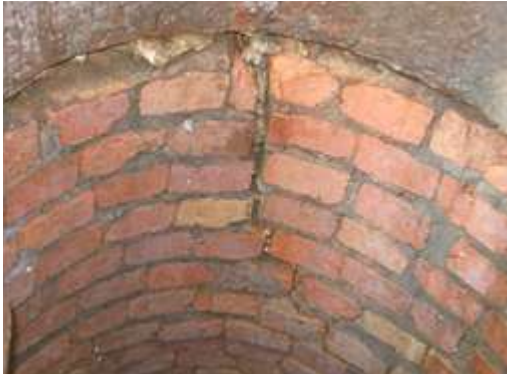
Miscellaneous

addtional crack from chimney to the corbel

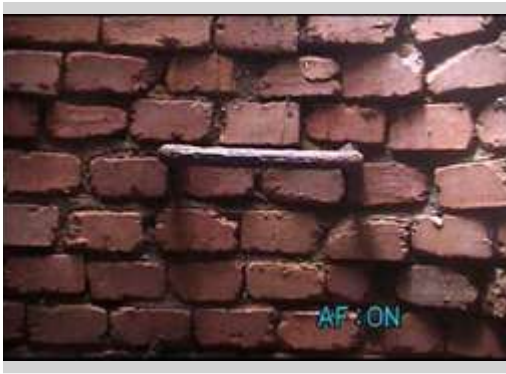
Defect 7

deteriorating barrel wall

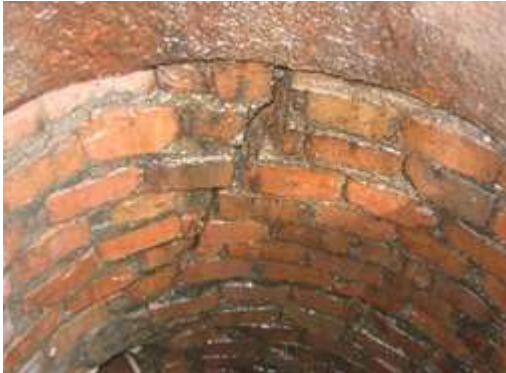
Defect 5

crack from the chimney to the corbel with active chimney infiltration from joint & crack

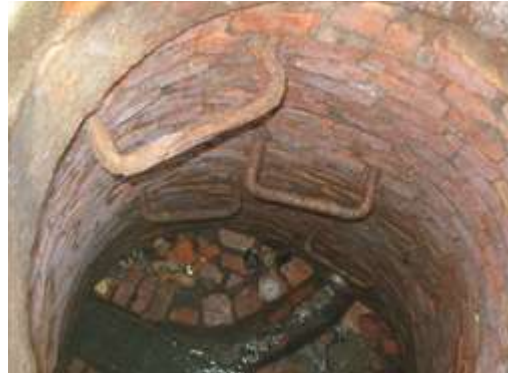
Defect 4

corroded rungs

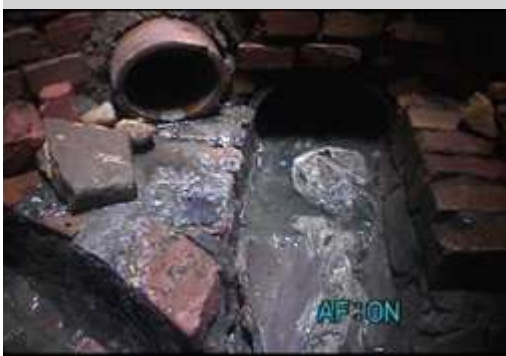
Defect 3

debris in the channel and on the bench

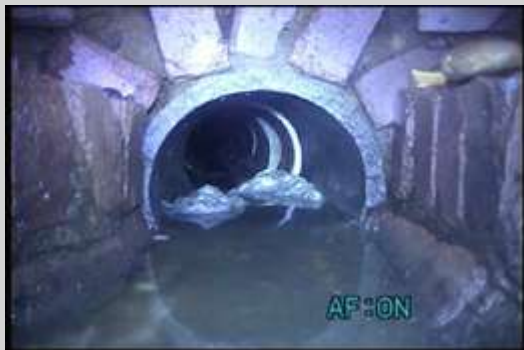
12 O'Clock Outflow

Misaligned joints in mainline

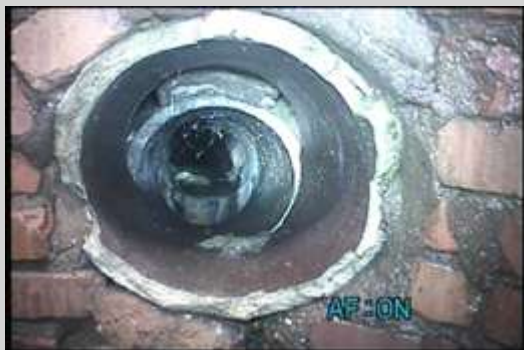
6 O'Clock Inflow

Pipe failure is eminent

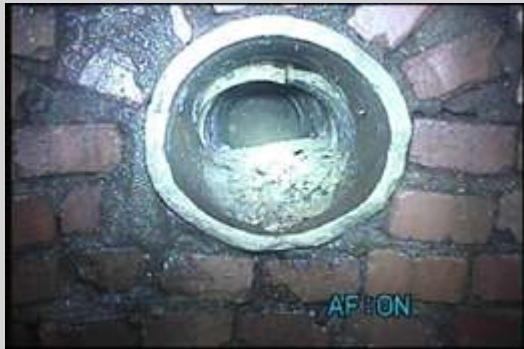
9 O'Clock Inflow

pipe is broken outside of manhole
